<b>Technical Information</b>	Date: 10.10.2016 Official: Heckl, Michael Department.: ST-FIR/MKP3
------------------------------	--

<b>Tech. Information No.</b>	2043 / 2016
<b>Subject:</b>	FMC-420RW/300RW manual call point - glass panes: CAR 160327

<b>Short Description:</b>	In a small number of cases it has been identified that Manual Call Points may not be triggered as intended after the glass pane has been broken
---------------------------	---

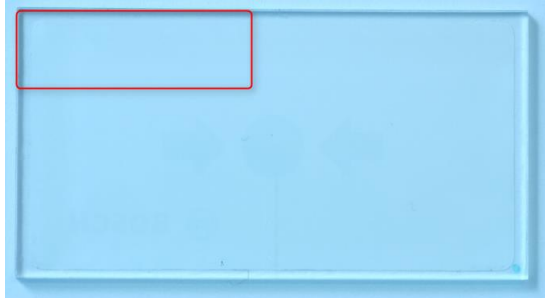
b) Back side of the glass pane  
No date printed/engraved  
**NO NEED TO EXCHANGE**

1. Double check during next inspection which version of the glass pane is used. You can identify 3 versions as described in *picture d)* is affected and should be replaced. (note: Versions in *pictures b)* and *c)* are not affected and do not need to be replaced)

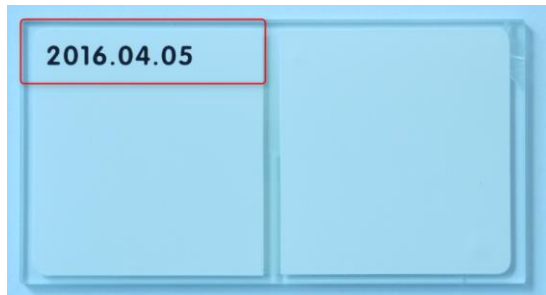
c) Back side of the glass pane  
Printed date  
**NO NEED TO EXCHANGE**

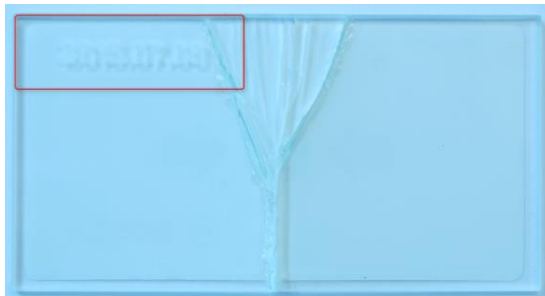
The issue is caused by a change in the design of the glass panes used in the Manual Call Point versions listed above.

The affected glass panes can be identified by a date code engraved on the backside of the glass panes (see picture d). These glass panes might break in an unexpected way resulting in a small number of cases in not triggering or delaying alarms. The products affected are those that were delivered between January 2014 and July 2016. This fault is not found in glass panes as described in pictures b) and c).

d) Back side of the glass pane  
Engraved date  
**PLEASE EXCHANGE**

During the next inspection, replace all affected glass panes in all installed Manual Call Points mentioned in this document.

- Replace affected glass panes, see *picture d)* for reference.
