Technical Information	Date: 24.11.2017 Official: Marier Department: ST-FIR/MKP3
------------------------------	---

Tech. Information No.	2130_A2 / 2017
Subject:	Potential connection issue old FK 100 LSN RF / new DOW1171-D

Short Description:	Potential connection issue between wireless detectors DOW1171-D and older FK 100 LSN RF installed in the field.
---------------------------	---

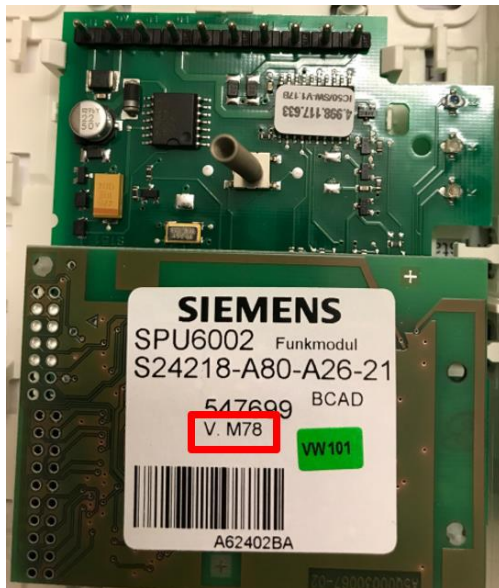
- The installed FK 100 LSN RF does not allow to log in and commission of the replacement detector(s) without problems.

Note: So far the log in issue has been reported only for gateways which contain the radio module SPU6002 with software versions M78 and older (e.g. M77, M75, ...) and have been installed before 2011.

- Aging of components on older FK 100 LSN RF.

SPU6002 with software version M78

- When a wireless detector (DOW1171-D) replacement is due, please keep in mind that it might be necessary to replace the gateway FK 100 LSN RF.

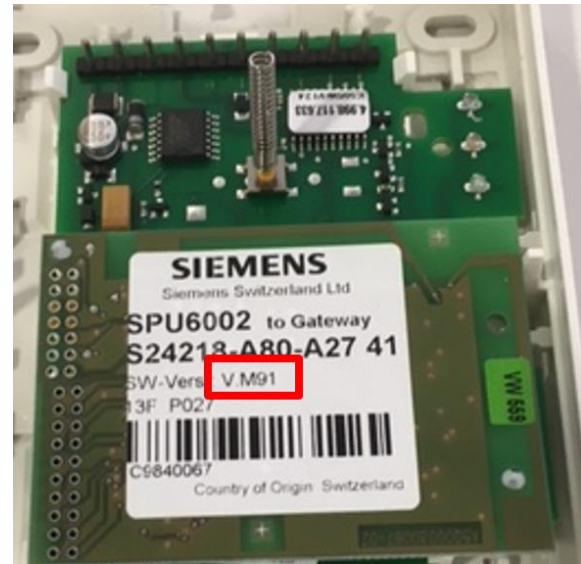
SPU6002 with software version M91
