Technical Information	Date: 12.07.2018 Official: Marier Department: BT-FIR/MKP3
------------------------------	---

Tech. Information No.	2134 / 2017
Subject:	FPA-5000 firmware 2.21.2: LSN module fault message on panel

Short Description:	Fault message in combination with LSN module V1.0.53 and true t-tap topology → "Exchange module now! See TI 2134/2017"
---------------------------	--

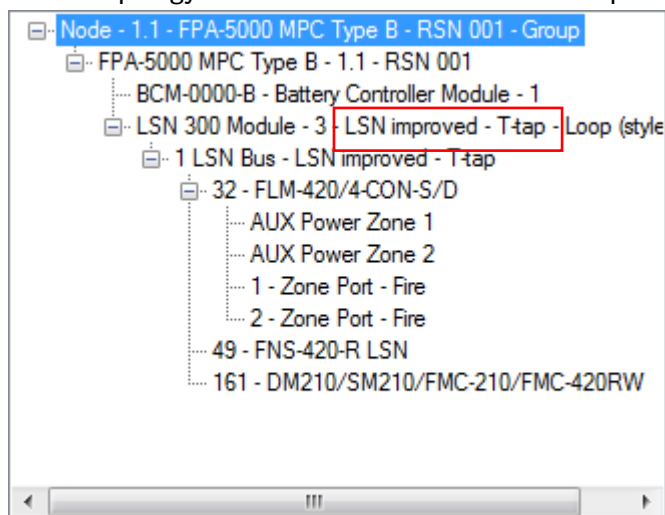
The problem is only occurring on LSN bus systems with manually addressed T-Tap topologies (mixed-topology or stub)!

In RPS the topology tree needs to be like shown in the picture below:

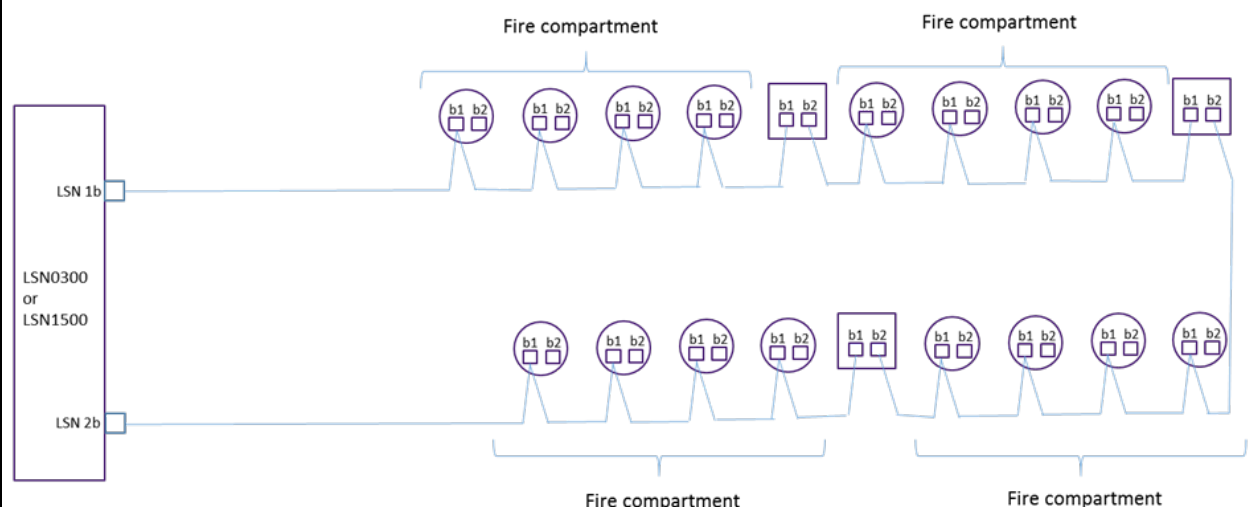
“True T-tap” means that the isolator function of the LSN elements is not used. In T-tap configurations the b-wires of the LSN-bus are only connected to one of the the b-connectors of the devices (e. g. b1). See example (round elements) below:

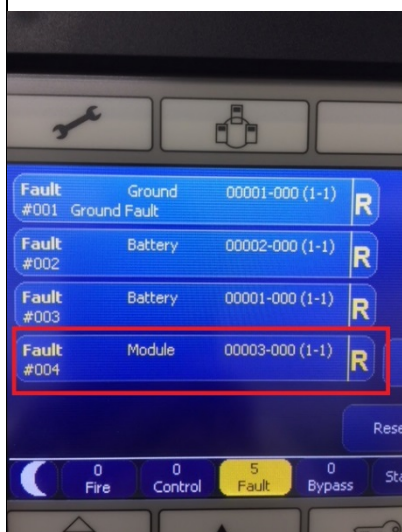
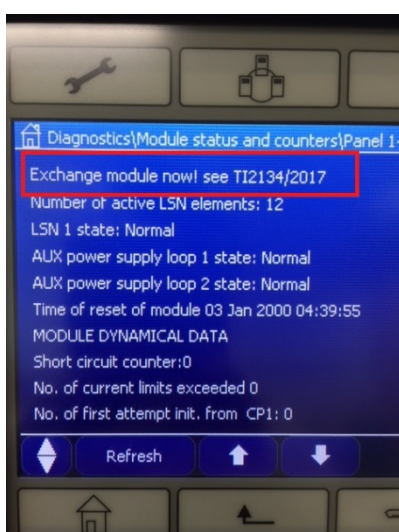
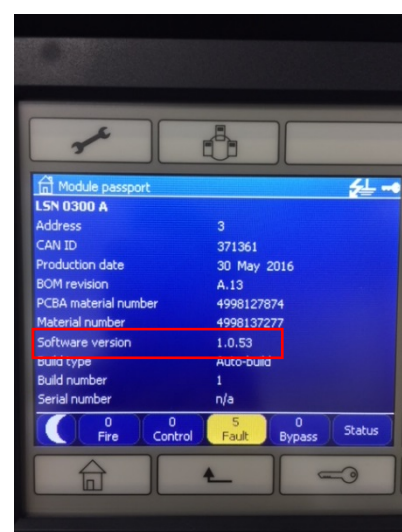
In case you have true T-tap topologies in your system and LSN modules with firmware V1.0.53 you will get a fault message as shown below:

In case your system is affected please provide photos of the fault messages on the MPC screen (similar to above) to ASA referring to TI 2134/2017.

You will then receive a replacement for the affected LSN modules.
