Technical Information	Date: 04.06.2018 Official: Marier Department: BT-FIR/MKP3
------------------------------	---

Tech. Information No.	2172 / 2018
Subject:	FPA-5000: new firmware 2.21.2 and RPS 4.10.3 release

Short Description:	<ul style="list-style-type: none"> - New feature: display of detectors 10-digit serial number/ID - Fixed: sporadic FNM-420 trouble - See "new features and "solved issues" below for detailed information
---------------------------	--

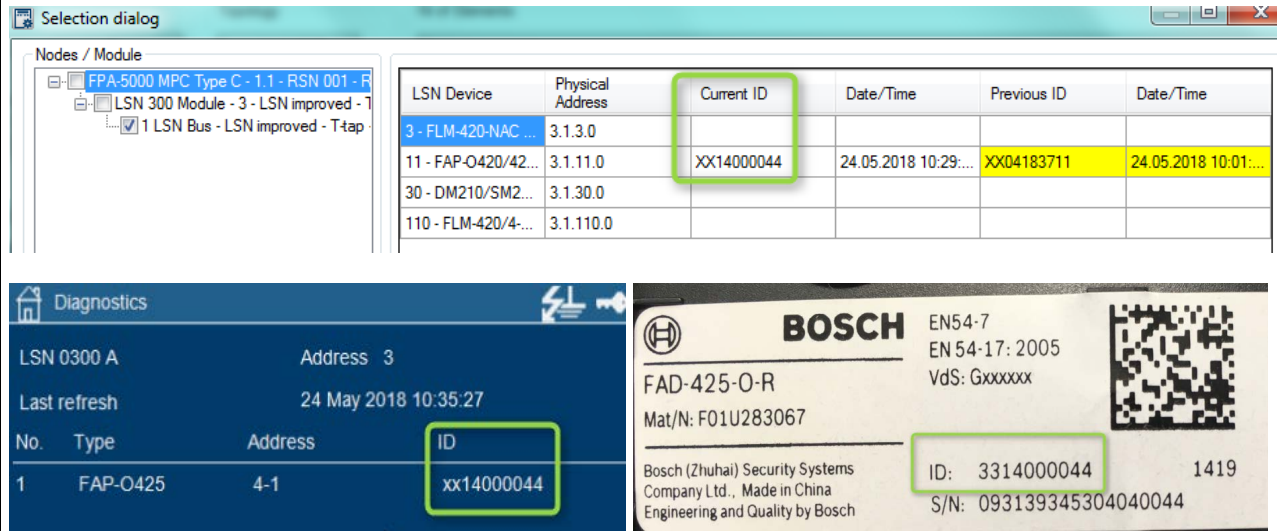
1.1. Display printed IDs of detectors in the panel and the RPS software

This feature allows to see the identical ID numbers printed on the detector label also in the panel. Detectors which are now identifiable by its 10 digit ID number, the first two digits are replaced by a XX. This applies to elements with the same type-ID but different type-code.

For RPS the first two digits are always represented as XX.
