| Technical Information | Date: 02.07.2021 Official: Marier Department: BT-FIR/MKP3 |

| Tech. Information No. | 2366 / 2021 |
| Subject: | Connect remote services to redundant panels |

| Short Description: | The solution specified in the networking guide to connect remote services to a redundant AVENAR panel, will generate a fault condition. A temporary workaround is available |

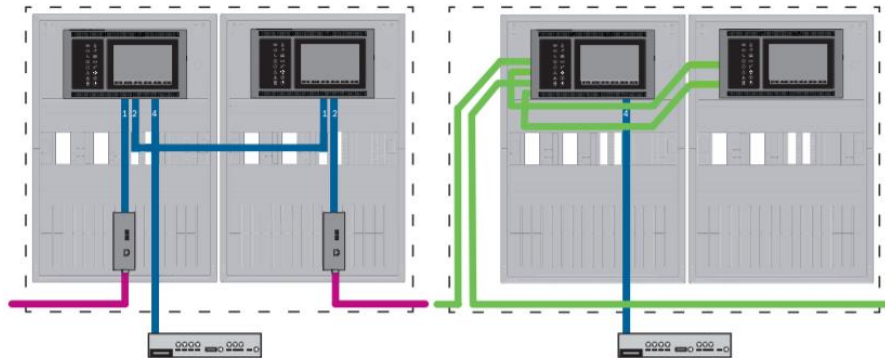
- Chapter 7.9 of the networking guide (08.2019|1|F.01U.378.914) illustrates how to connect remote service gateway to AVENAR panel equipped with a redundant panel controller.

Picture 1: Connection described in networking guide (version 1)

- Because nothing is connected to ETH4 port of the redundant panel, an ETH4 fault condition will be generated. This is not only the case when you have a network of CAN or Ethernet, but also a stand-alone panel with redundancy
- A temporary workaround is connecting the remote service gateway only to the ETH4 port of the redundant controller, like shown on the picture 2 below.
- For CAN networking an Ethernet cable is additionally required between master and slave from ETH2 Master to ETH2 Slave

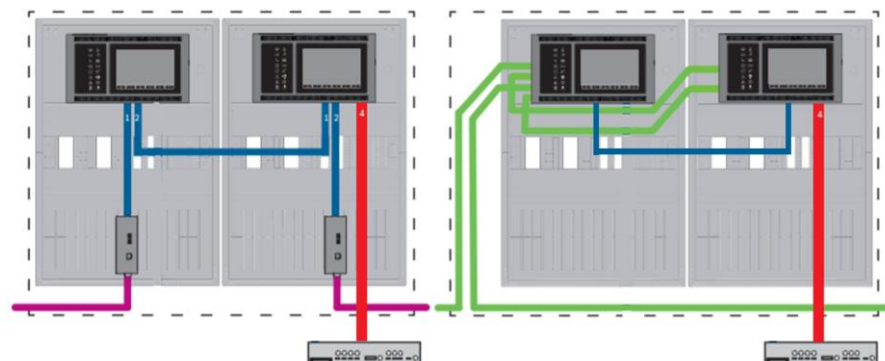
Picture 2: Temporary workaround to connect remote service with a redundant panel

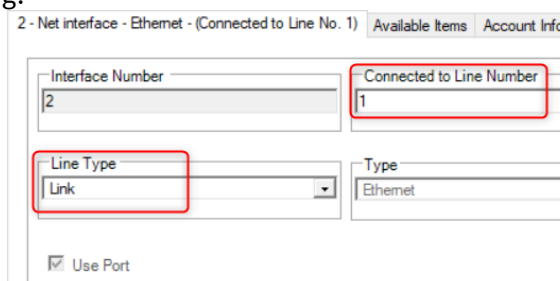
Picture 3: Settings in RPS

- In FSP-5000-RPS, the settings for ETH2 should be configured as followed (see picture 3), when using CAN networking:

Line number must be "above 0" to have the connection supervised

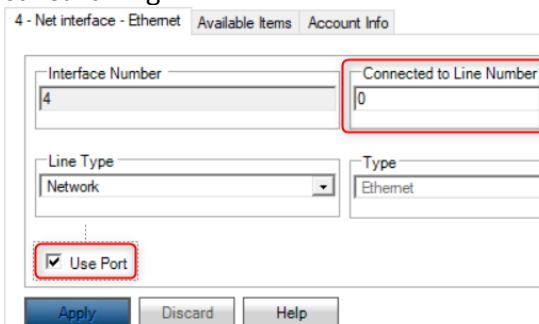
Picture 4: Settings in RPS

- In FSP-5000-RPS, the settings for ETH4 should be configured as followed (see picture 4), when using CAN and ethernet networking:

Line number must be "0" and "use port" should be marked

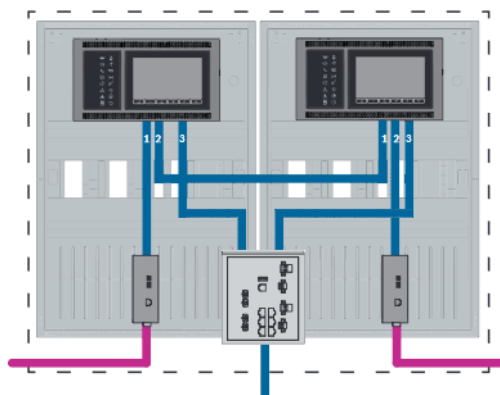
Picture 5: connection of VAS and UGM interface to AVENAR panel with redundant panel controller

- When feasible, please consider connecting the remote service gateway to an AVENAR panel without panel redundancy.
- This workaround is temporary and will change in future. Take this into account during installation by e.g.: keeping sufficient cable length buffer to reach the main panel controller.
- This workaround is also applicable for the connection to building management systems via FSI/OPC. In this case port ETH3 of the redundant panel controller must be used and configured.
- This workaround is not suitable for life safety relevant connections to voice alarm systems (VAS over IP) and hierarchy panels (UGM). An EN54 certified switch connected to the main and redundant panel controllers has to be installed as shown in picture 5.
