<b>Technical Information</b>	Date: 26.05.2015 Official: Marier Department.: ST-FIR/MKP3
------------------------------	--

<b>Tech. Information No.</b>	1924 / 2015
<b>Subject:</b>	The relays of the FLM-420-RLV8-S cannot be activated

<b>Short Description:</b>	Bending the FLM-420-RLV8-S can damage the PCBA. Test the relays during commissioning and maintenance.
---------------------------	--

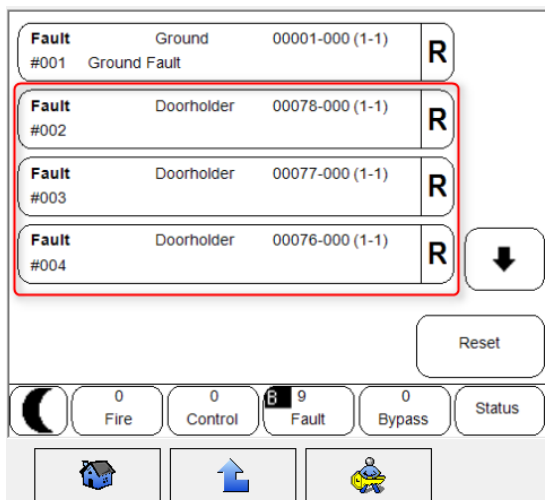
- Assign an address to all eight relay outputs and select usage type "door holder" with standby mode ON (default)
- Upon re-configuration and system re-boot all eight "door holder" outputs of a faulty FLM-420-RLV8 will be displayed in FAULT.

When a faulty FLM-420-RLV8-S is identified in the field, please start a RMA procedure for the replacement with the comment CAR150139.

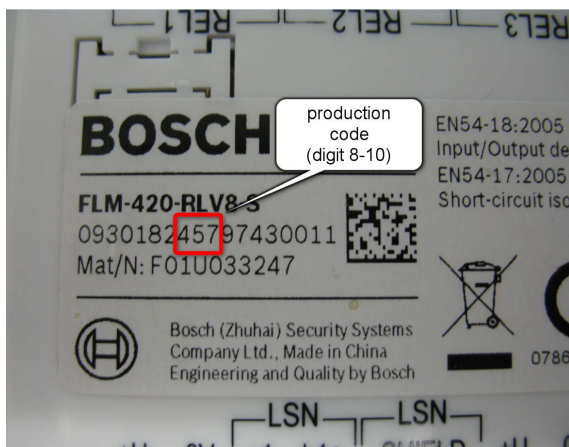
In order to eliminate the root cause of the failure, our engineers optimized the plastic housing. This will prevent to bend the PCBA when it's exposed to mean pressure.

\* The optimized housing can be identified through the production code, starting with production code '519' (March 2015).
