Technical Information	Date: 27.10.2015 Official: Marier Department.: ST-FIR/MKP3
------------------------------	--

Tech. Information No.	1961 / 2015
Subject:	Power supply housing PSF-0002 A and PMF-0004 A 230V~ wire insulation nicked / tie-wrap in false position

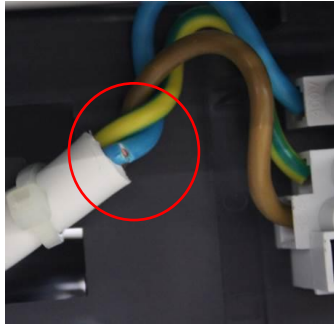
1. The wire insulation was nicked on the 230V~ cable, in one case down to the bare wire. See picture.

Incident during cable stripping and pre-wiring process

- The cable supplier has been informed to take corrective action.
- Housings on stock are currently being inspected and will be un-blocked after inspection is completed.
- If such a case is detected on site the electrician/skilled technician is required to assess the situation and if necessary to take proper corrective action.

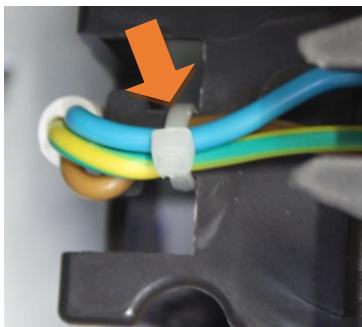
false

2. The tie-wrap was wrapped around the wire insulation (improper strain-relief) and not around the cable sheath.
