# Technical Information 2638/2025

## Modular Alarm Plattform 5000

MAP5000 Panel update “via Direct connect”

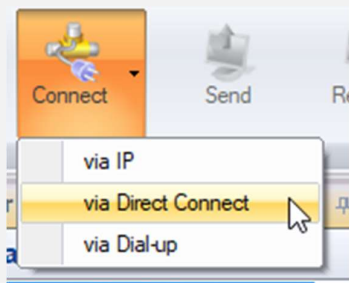
**Panel connection via Direct Connect > FW update****Fault description:**

Connecting with the panel and standard data transfer for configuration and maintenance is possible but in rarely cases the FW update cannot be started and an error message is displayed.

**Solution:**

If the error occurs, FW update must be done by “via IP” connection.

Generally, it is recommended to use “via IP” connection method for any installation and maintenance activities on MAP5000.

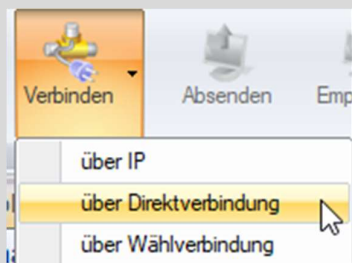
**Zentralenverbindung über Direktverbindung > FW update****Fehlerbild:**

Die Verbindung mit der Zentrale und der Standard-Datenaustausch für Konfiguration und Wartungsarbeiten ist möglich, aber in seltenen Fällen kann das FW update nicht gestartet werden und eine Fehlermeldung wird angezeigt.

**Lösung:**

Sollte der Fehler auftreten, ist für das Firmware Update die Verbindungsart „über IP“ zu verwenden.

Grundsätzlich wird empfohlen für alle Installations- und Wartungsarbeiten der MAP5000 die Verbindungsart „über IP“ zu verwenden.
