Technical Information	Date: 27.10.2015 Official: Marier Department.: ST-FIR/MKP3
------------------------------	--

Tech. Information No.	1961 / 2015
Subject:	Power supply housing PSF-0002 A and PMF-0004 A 230V~ wire insulation nicked / tie-wrap in false position

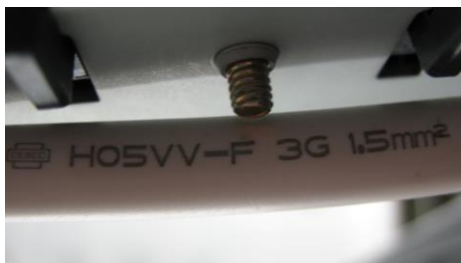
2. The tie-wrap was wrapped around the wire insulation (improper strain-relief) and not around the cable sheath.

(cable type used in above mentioned housings)

- The cable supplier has been informed to take corrective action.
- Housings on stock are currently being inspected and will be un-blocked after inspection is completed.
- If such a case is detected on site the electrician/skilled technician is required to assess the situation and if necessary to take proper corrective action.
